By Tereza Pultarova

# Soyuz TMA-11 Ballistic Reentry

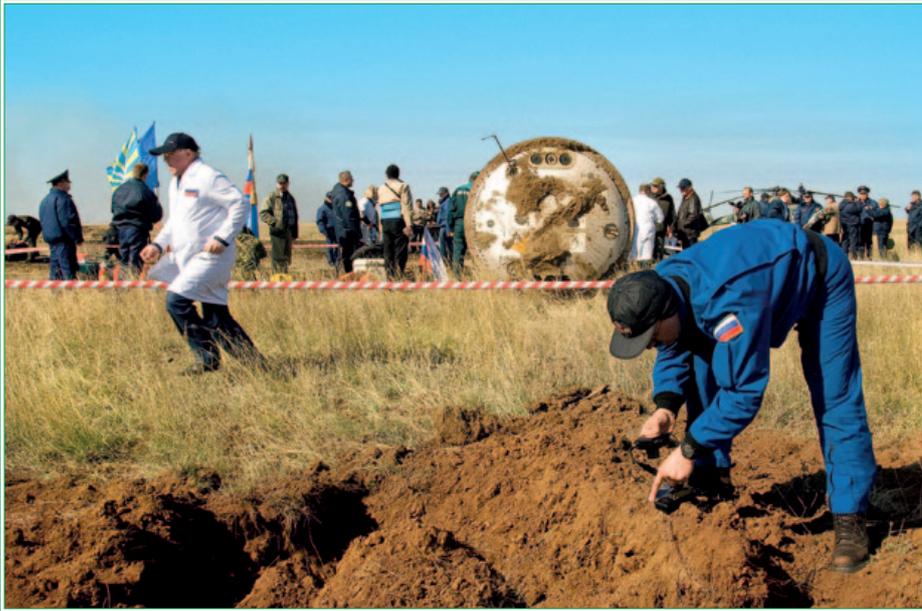
A Russian ground crew member examines the over turned soil near the Soyuz TMA-11 spacecraft after it landed. - Credits: NASA/Reuters/Pool

Soon, the improper separation of the propulsion and service module was identified as the most probable culprit. Yuri Malenchenko reported signs of smoke during the reentry inside the capsule, and an examination revealed more extensive heat damage. According to the investigation the service module was still loosely connected to the spacecraft during entry in the upper atmosphere. As a consequence the correct orientation of the capsule was impossible. Instead of flying with the heat shield first, the capsule with the module still attached was hurtling with the entry hatch forward exposing it to extreme heat loads.

Insiders familiar with the investigations told the Russian press agency Interfax that the heat damage could have led to the loss of pressure inside the capsule. Also damaged was an external portion of the valve which balances the pressure between interior and exterior and so was the communication antenna.
